HV Forming System Forming Equipment

Shores, Dropheads and Beams

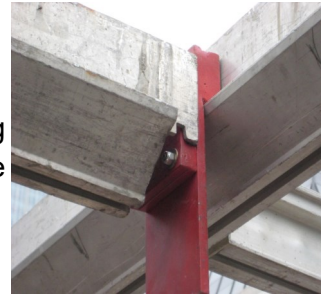
The safe working load of brackets is 3,700 lbs.

Shoring requirements are as follows:

- Slabs up to 12 inches require **NO** additional shores.
- Slabs over 12 inches require shoring
- HV drop deck brackets (Epic 700-039) are available from the equipment group. Please allow sufficient lead time to manufacture the brackets.

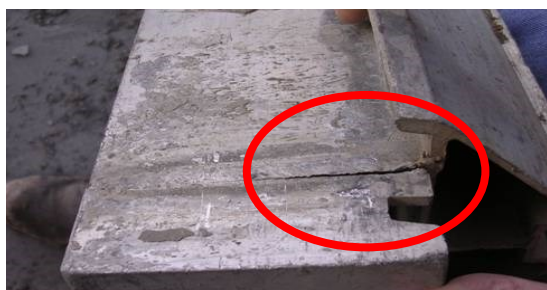
Note: This photo shows a large weld crack. Usually the cracks are smaller, often only 1/8" long.

A small crack will grow if the main beam is not removed from service and could eventually fail.

Note: This photo shows a crack in the clip running at a 45 degree angle from the notch. Often the crack is just a hairline.

A vertical crack on the other side of the clip is sometimes observed on main beams that have been dropped.

Cracks have been observed in clips that are not bent.

REMOVE cracked HV main beams from service.

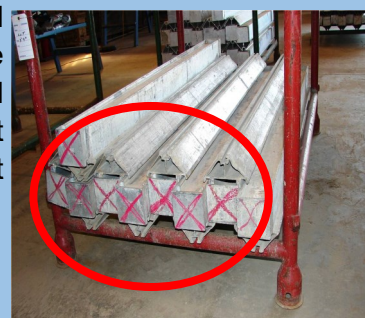
Note: Damaged equipment must be removed and **MARKED** to show that it is damaged and that it cannot be used.

Use a paint stick and mark **ONE** end of the damaged beams. This is the best method to alert yard personnel that the marked equipment is in need of repair. Also, keep damaged equipment separate and **DO NOT** mix it with undamaged equipment.
